REDPOINT LLC

Inspection Report

1234 Main St.
Bozeman MT 59718

Date: 6/10/2016	Time: 09:00 AM	Report ID:
Property: 1234 Main St. Bozeman MT 59718	Customer: Joe Customer	Real Estate Professional:

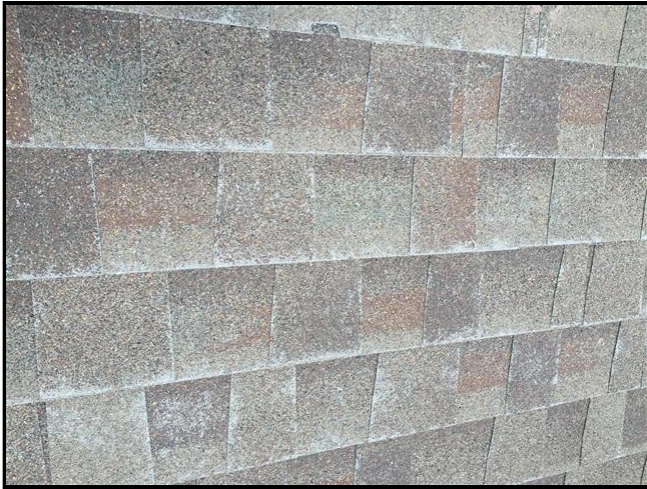
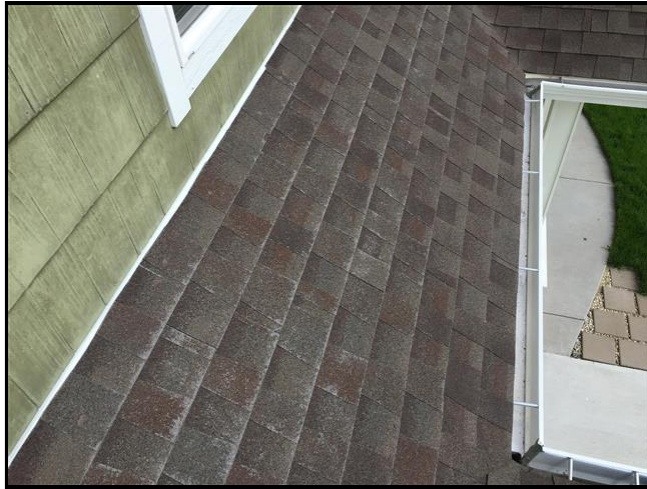
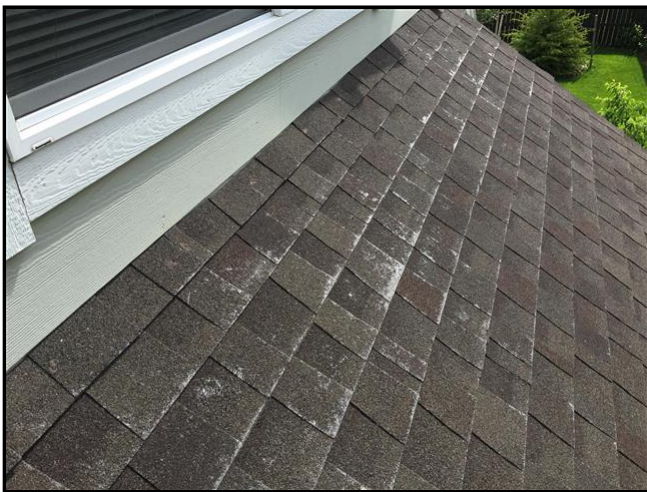
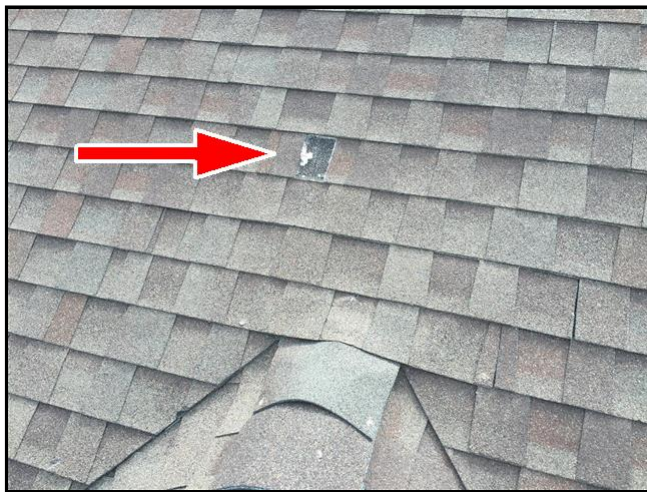
1.0 Overall the condition of the roof is consistent with its age. However, general deterioration of the roof covering was observed. The fiberglass underlayment was exposed along the edges of many shingles. The most significant damage was present on the south side, where some of the shingles may require replacement. In addition, there was one missing shingle tab on the west side, just behind the garage ridge line, which will require repair. The estimated remaining useful life of this roof is 5 years.

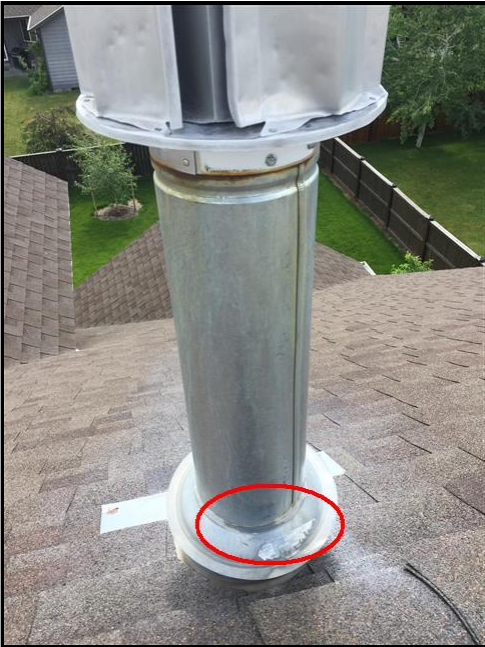
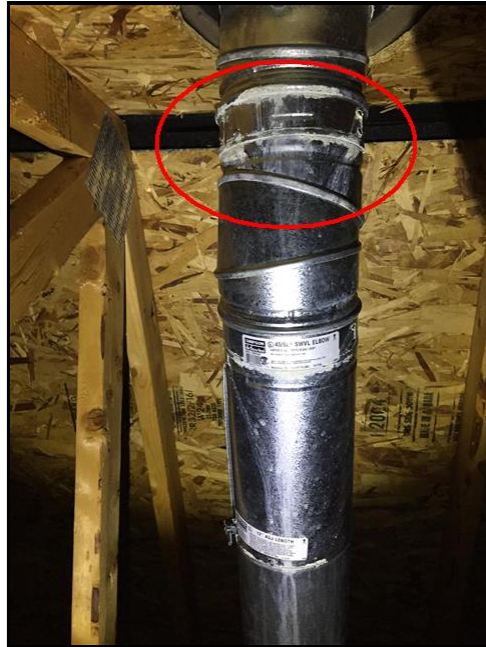
1.2 Recommend the sealant around the flue vent pipe, center of the roof, be replaced/improved to prevent water intrusion and deterioration. There was minor deterioration visible on the pipe, specifically on the interior of the attic. The corrosion present does not appear to be affecting the integrity of the pipe and no water staining or damage is present on the roof decking or interior components. This is currently considered a maintenance item.

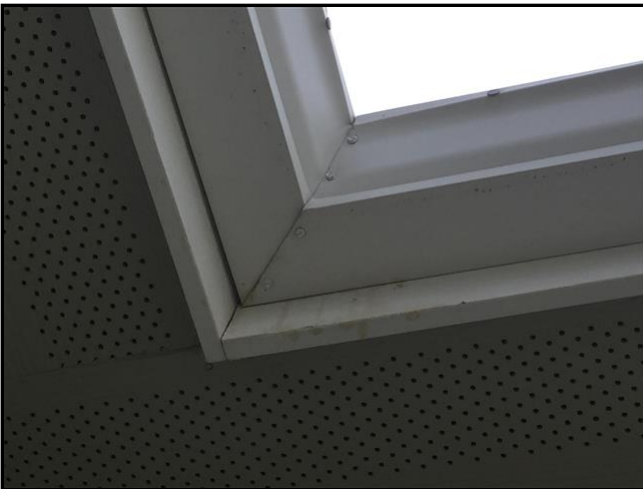
1.3 Item 1(Picture)

1.3 Water staining is present on the fascia behind the gutter right of the front porch. This gutter corner is likely leaking and should be sealed. This issue has not caused any damage, so this is currently considered a maintenance item.

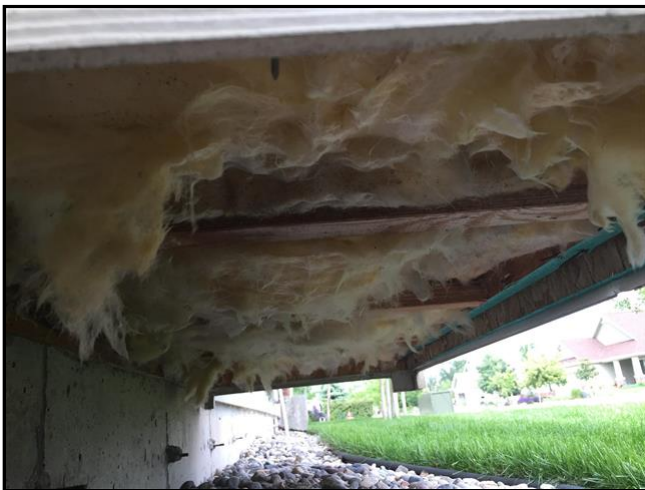
2.0 Item 1(Picture)

2.0 (1) There was no plywood or siding installed on the bottom of the chimney wall assembly. The insulation is exposed and some deterioration was present. Hidden damage may also be present and further evaluation and repair is recommended by a qualified contractor.

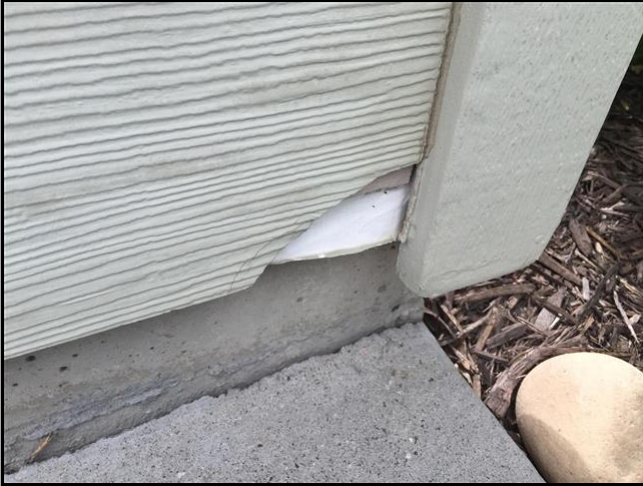
(2) Minor damage was observed on the siding in several locations. Of specific note is the damage near grade level at the SE corner of the house; the crack below the 2nd story window on the south side; and the missing corner piece just right of the garage overhead door.

2.0 Item 2(Picture) Right of garage

The paint has faded and the home will need to be repainted within the next 2 years. This is considered a maintenance/cosmetic item at this point.

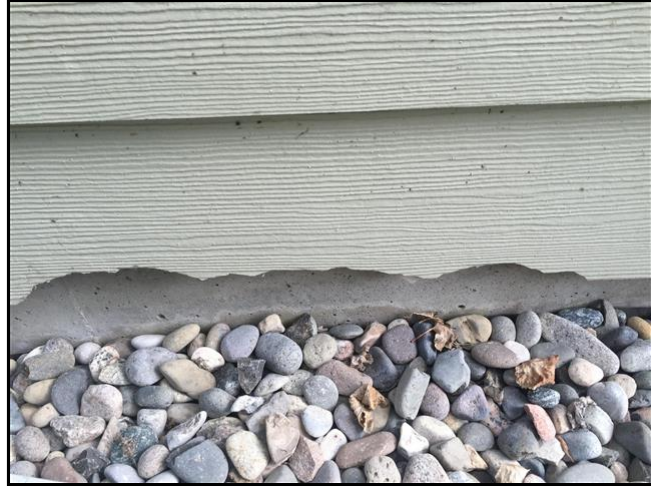
2.0 Item 3(Picture) Right side, rear

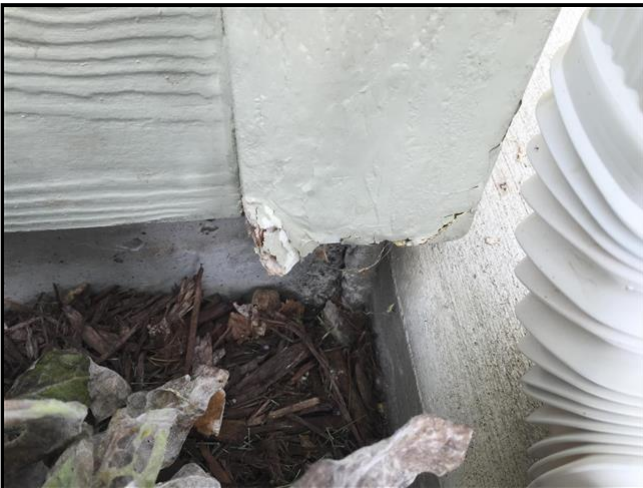
2.0 Item 4(Picture)

(3) There is damage to the bottom trim, near grade level, at the rear of the house near the gas line for the grill. Recommend the damaged trim be repaired/replaced.

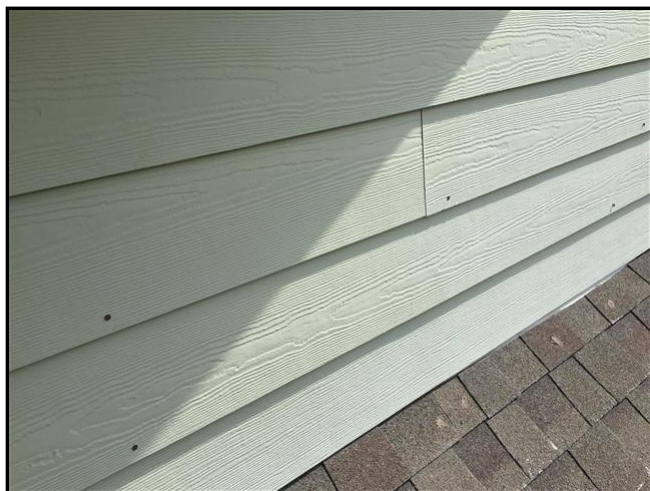
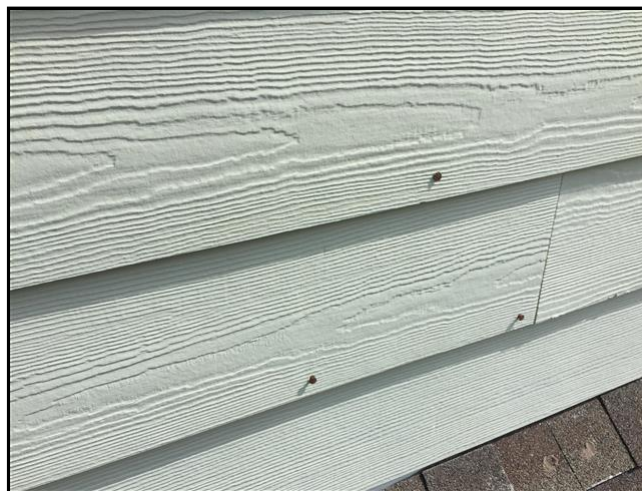
(4) Nails were added to the siding on the second level on the right side of the house, which are rusting and beginning to pull away from the siding. It is unclear why these nails were installed. Recommend they be removed and the holes sealed. This has not caused any visible damage and may be considered a maintenance item.

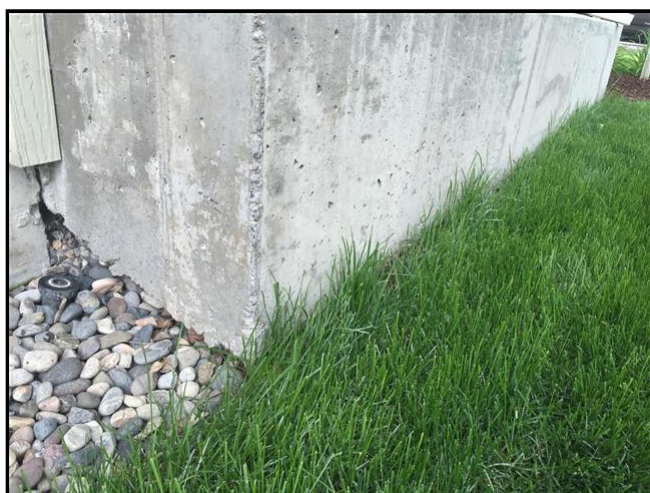
2.4 Item 1(Picture)

(2) Some erosion is present at the bottom of the front porch slab, left side. This has not caused any settlement and no immediate action is necessary. Recommend the missing soil be replaced and the area monitored. This is a maintenance item.

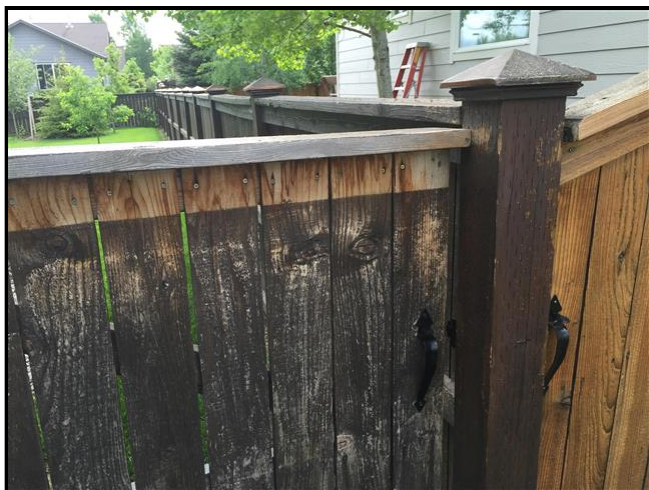
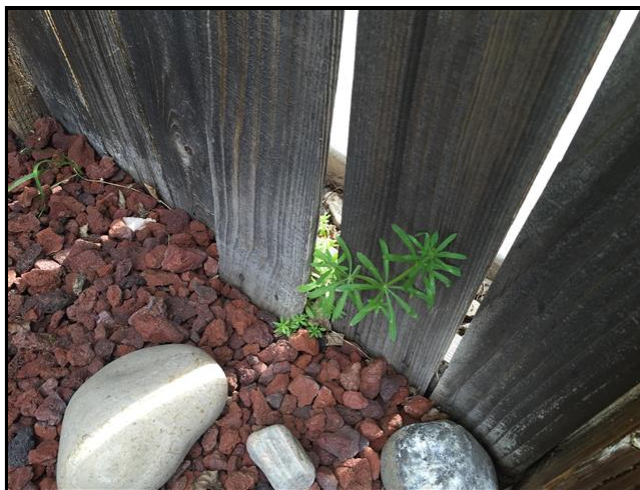
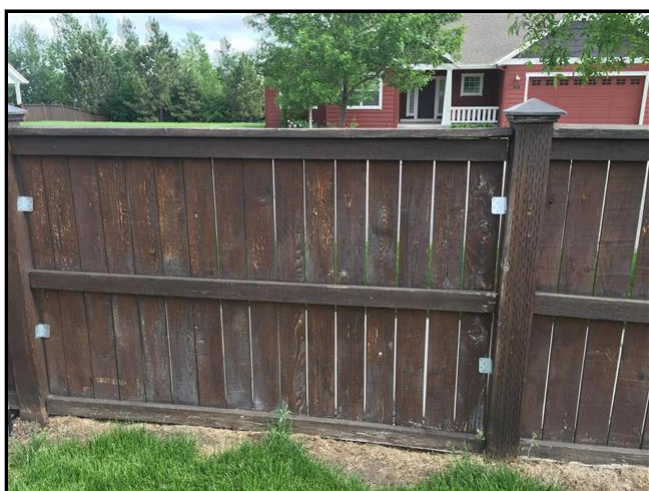
2.6 General deterioration of the fencing was observed, with minor damage to the top plate, broken/loose slats, and deteriorated wood present in multiple locations. In addition, the gate on the south side binds on the post and will require service. It was also noted that one of the fence panels on the north side was recently removed and replaced, with temporary hardware still securing it in place. Recommend these issues be addressed by a qualified contractor.

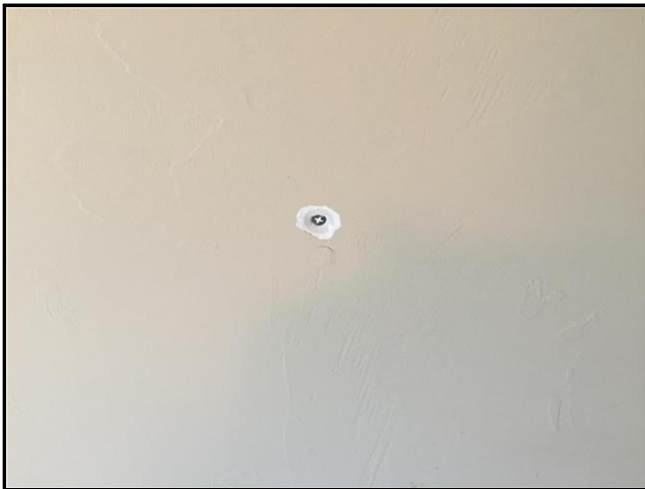
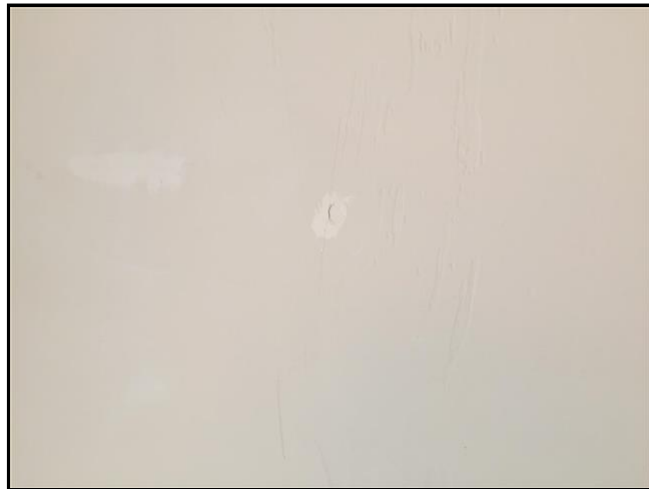
4.1 (1) There are several nails protruding from the drywall in the center bedroom upstairs. This is considered a cosmetic item.

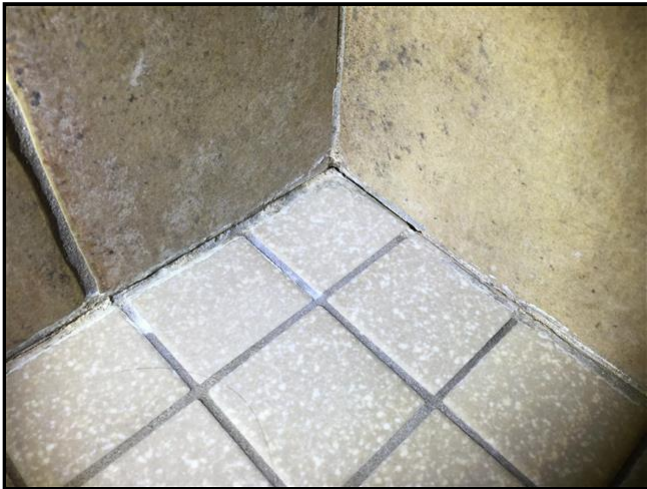
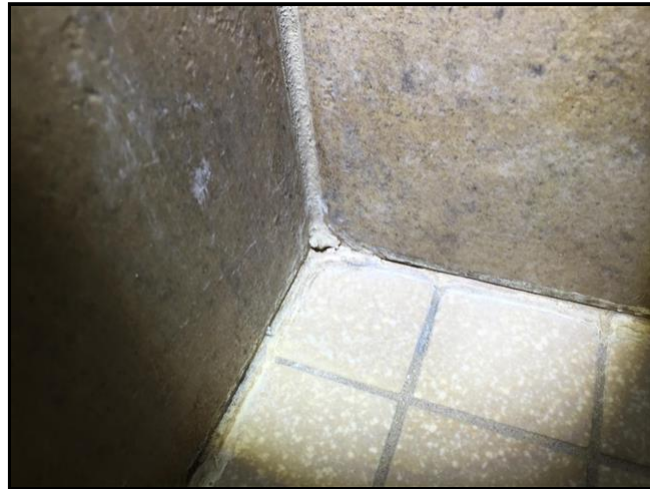
(2) Recommend the corners and seams in the master bathroom shower enclosure be sealed to prevent water intrusion behind the tile. There was no evidence of water damage on the day of the inspection and this is currently considered a maintenance item.

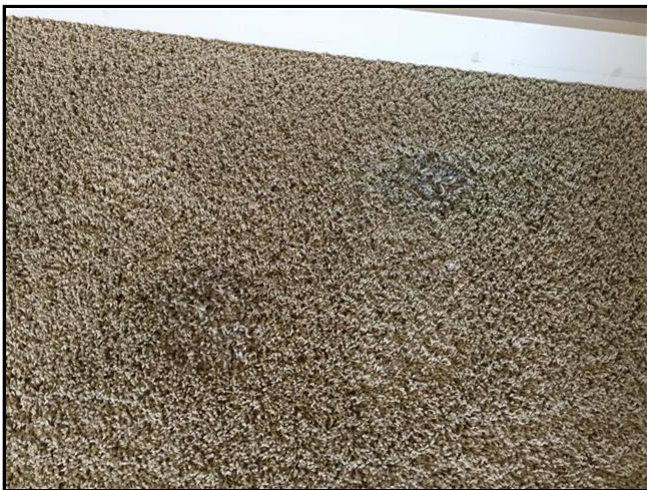
4.2 (1) Staining is present on the carpet in multiple locations, including the master bedroom, stairs, and upstairs bedrooms. The carpet may need to be replaced in these locations, however this is considered a cosmetic item.

4.2 Item 1(Picture) Master bedroom

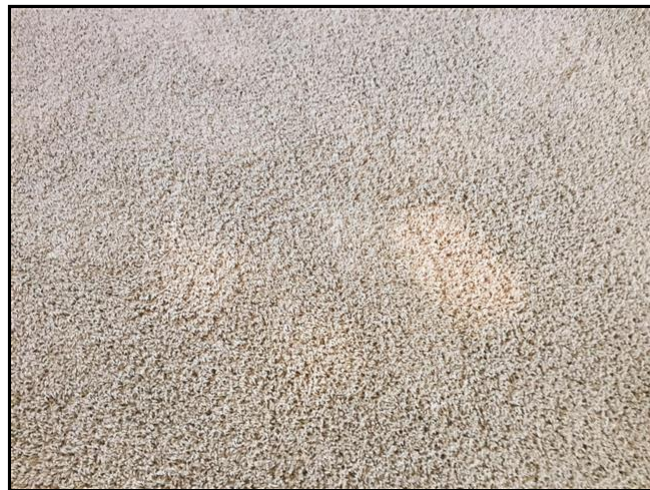
4.2 Item 2(Picture) Bedroom #1 Upstairs

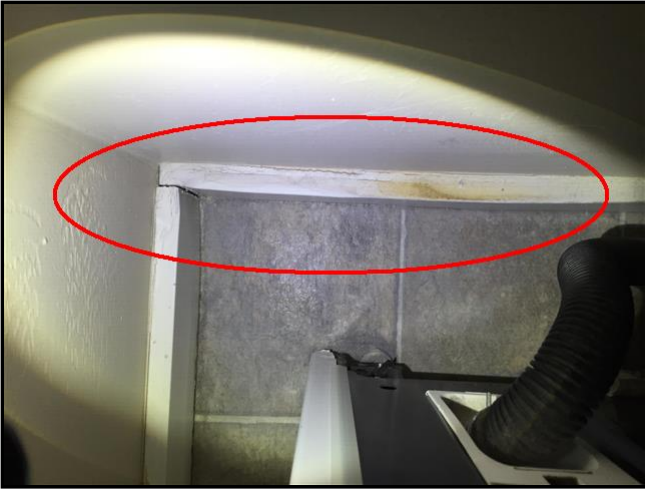
4.2 Item 3(Picture)

(2) The baseboard trim is swollen from past water issues behind the washer in the laundry room. The owner stated there was a past flood in the room and that the flooring in the laundry room and hallway had to be replaced. Moisture readings were acceptable on the day of the inspection and the water issue has been addressed.

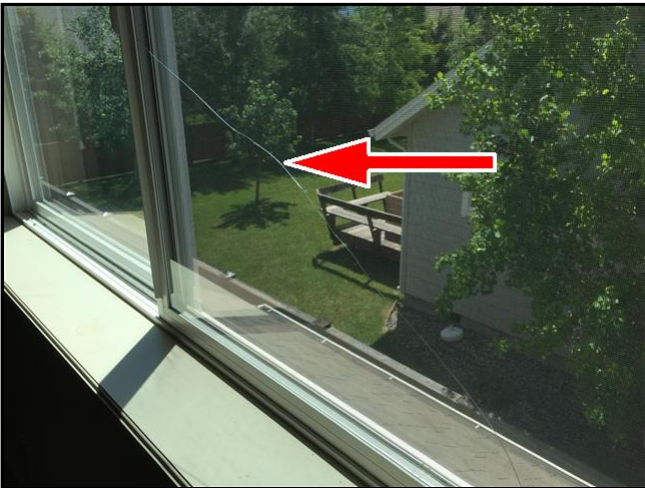
4.6 Item 1(Picture)

4.6 The window is cracked on the 2nd level, south side. This window will require replacement by a qualified contractor.

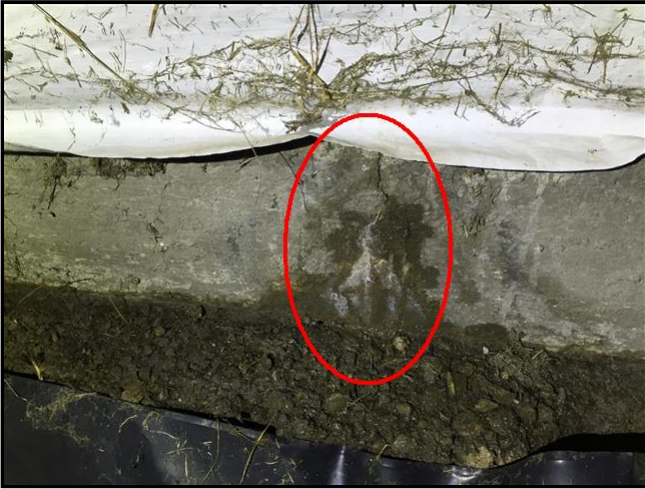
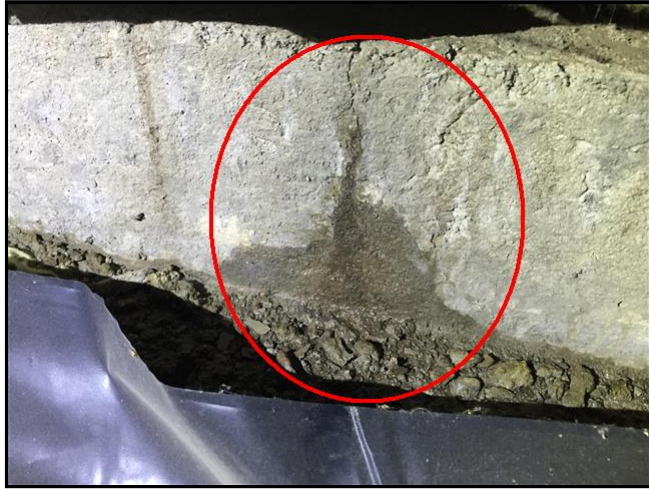
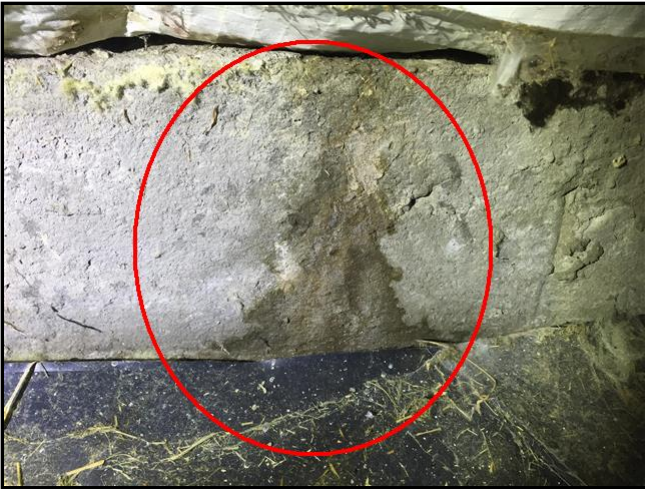
5.0 There are several minor cracks in the foundation at the base of the wall assembly. These cracks are not structurally significant but are dripping water into the crawl space. This has caused any significant water accumulation or damage. Recommend these cracks be sealed and monitored.

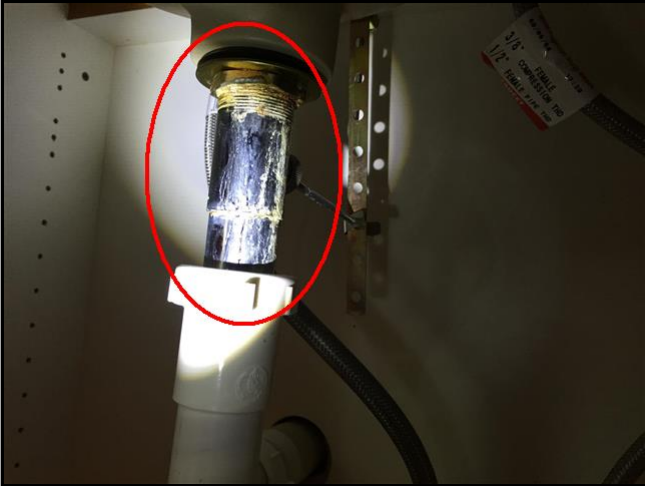
6.0 Item 1(Picture)

6.0 There is evidence of a past leak at one of the sink drains. No active leaking was observed but staining was present. Recommend the fixture be monitored, however no immediate repairs are necessary.

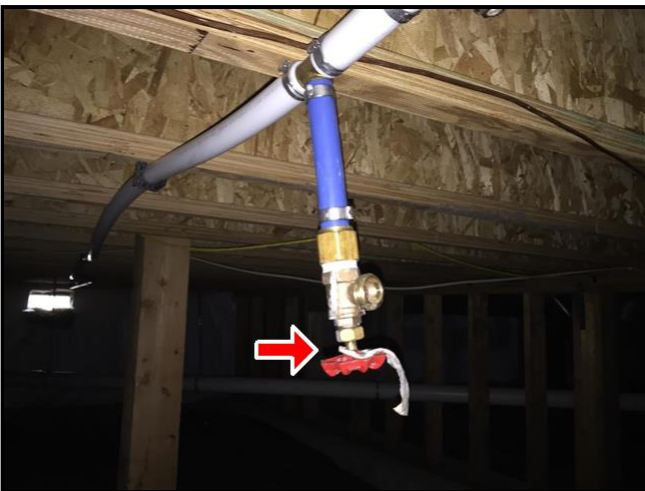
6.1 Item 1(Picture)

6.1 (1) The blow out valve near the main water supply shut off to the irrigation system, leaks continuously and will require repair/replacement.

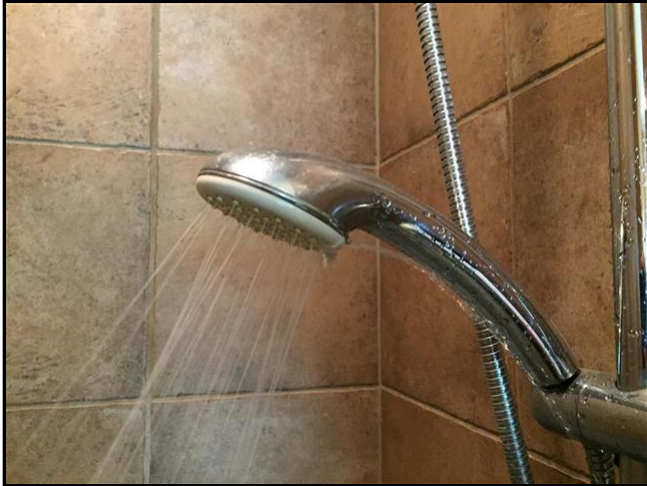
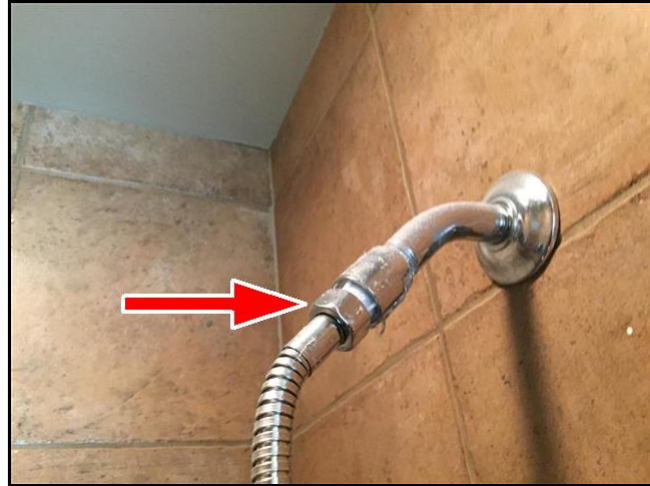
(2) The master bathroom shower fixture leaks at the connection to the service pipe and at the head. Recommend this fixture be repaired or replaced.

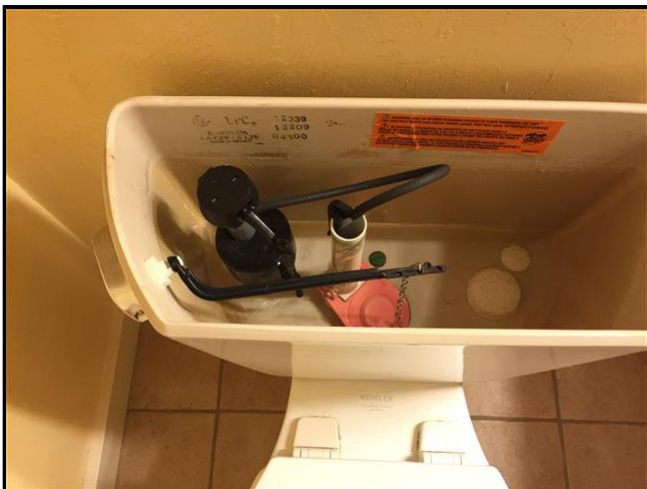
6.1 Item 4(Picture)

(3) The toilet handle must be held down to flush the toilet in the upstairs hall bathroom. Recommend the tank assembly components be serviced or replaced. This may be considered a maintenance item.

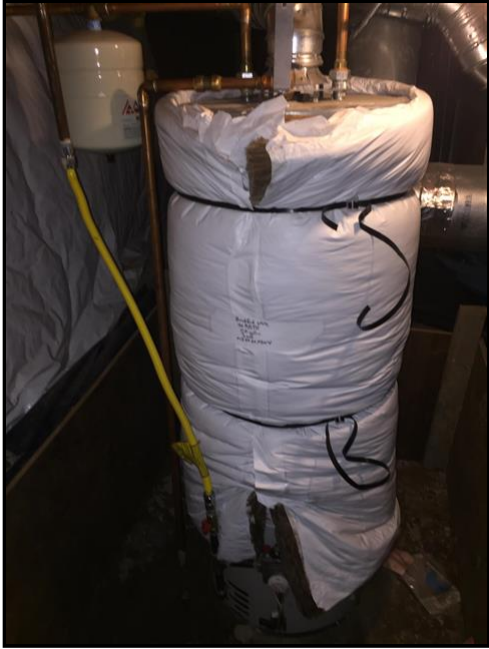
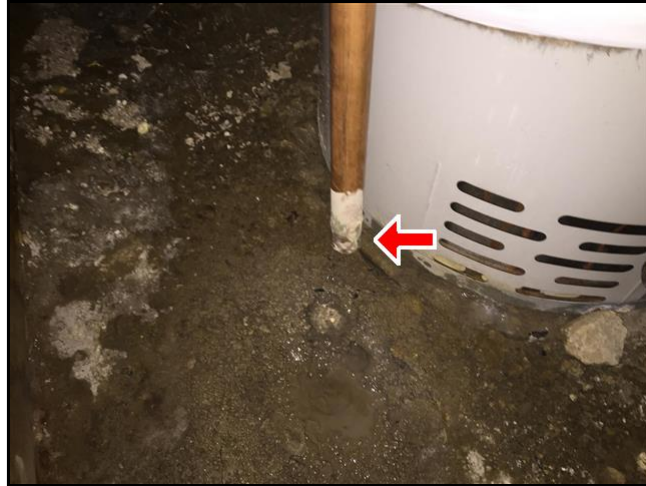
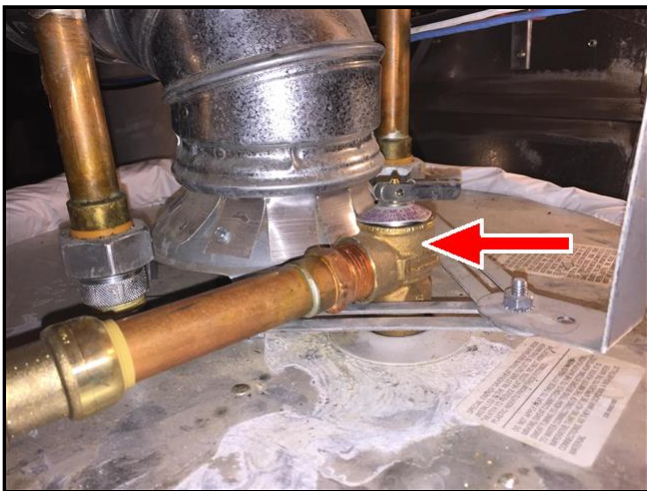
6.2 The TPR (temperature/pressure relief) valve allows water to leak out continuously onto the ground below. Recommend this valve be replaced by a qualified plumbing contractor.

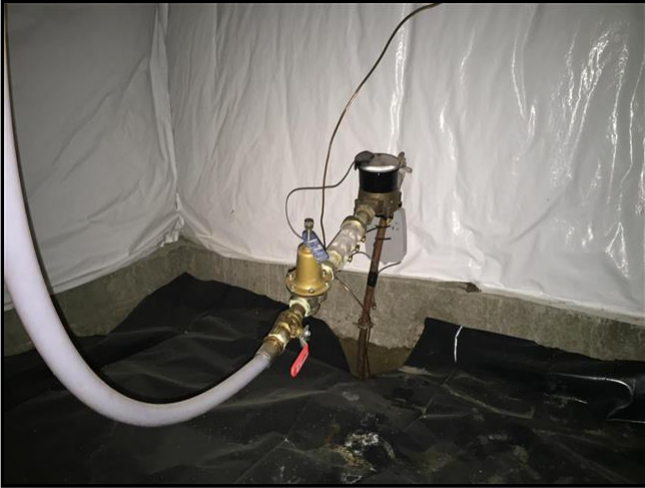
6.3 Item 1(Picture)

6.3 The meter and valve assembly are not properly supported. There was no damage and no visible leakage was observed but the current arrangement places strain on the connections and should be addressed.

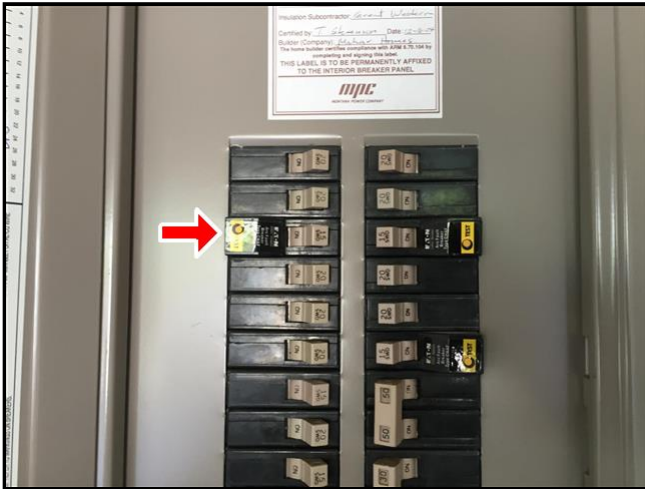
7.2 Item 1(Picture)

7.2 (1) The AFCI (Arc Fault Current Interrupter) breaker on the left side of the garage panel (yellow button) fails to trip when tested. This is a potential fire safety risk. Recommend this breaker be replaced by a qualified electrician.

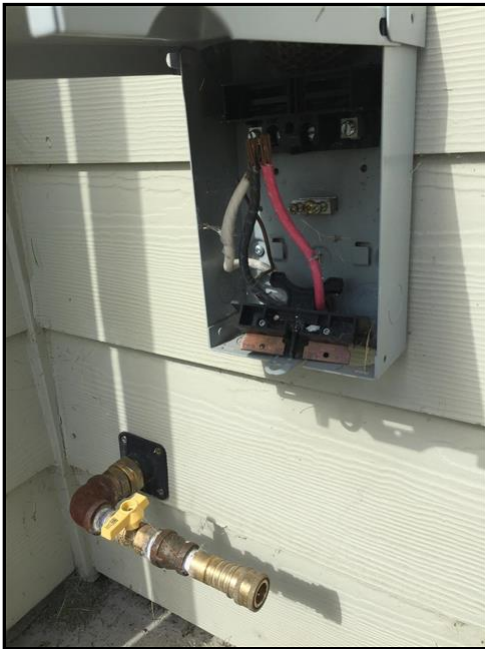
7.2 Item 2(Picture)

(2) The wires inside the hot tub sub-panel on the rear patio are exposed. The breaker is off to this sub-panel but if it is turned on the wires would be energized. Recommend this box be locked and/or the wires capped/protected.

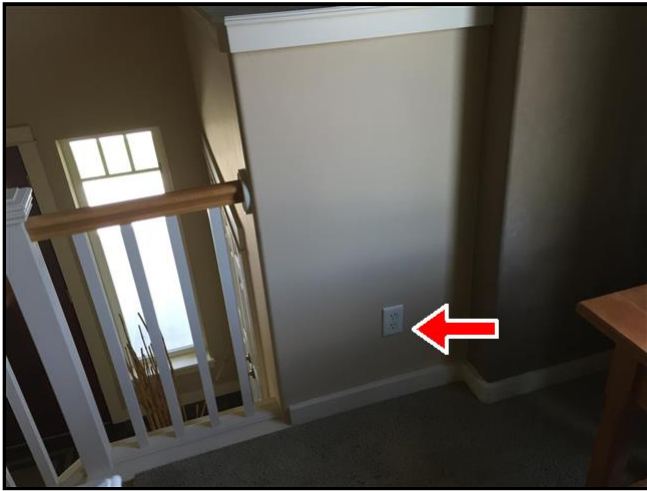
7.3 (1) The outlet right of the garage overhead door has a piece of metal stuck in the ground receptacle. In addition, the outlet at the stairway landing also has something stuck in the ground receptacle. Recommend these two outlets be addressed or replaced by a qualified electrician.

7.3 Item 1(Picture) Stairway landing, bottom receptacle

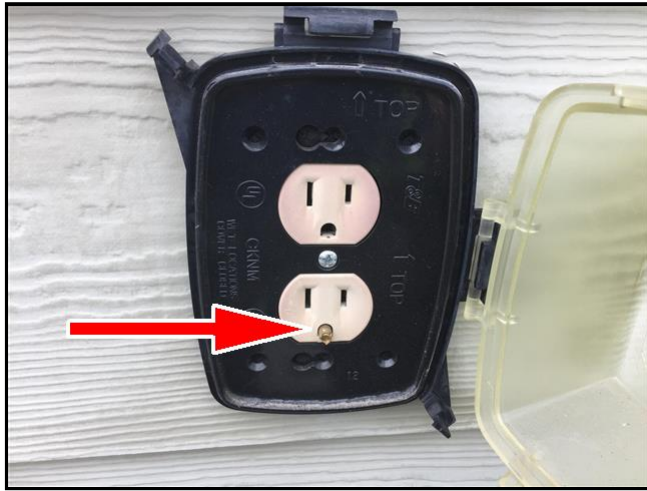
7.3 Item 2(Picture) Right of garage

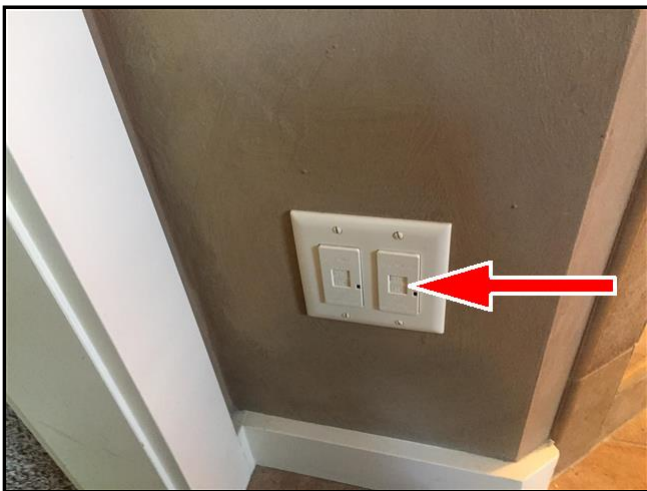
7.3 Item 3(Picture)

(2) The right GFCI switch in the master bathroom does not trip when tested. It is unclear what this GFCI services because the left unit services the jetted tub. Further evaluation will be necessary.

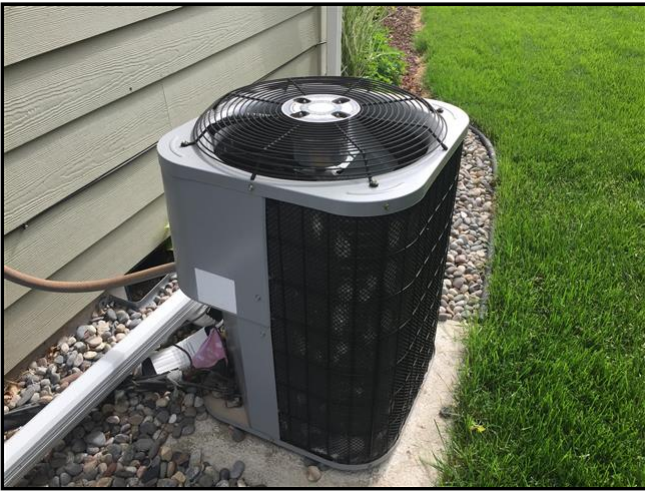
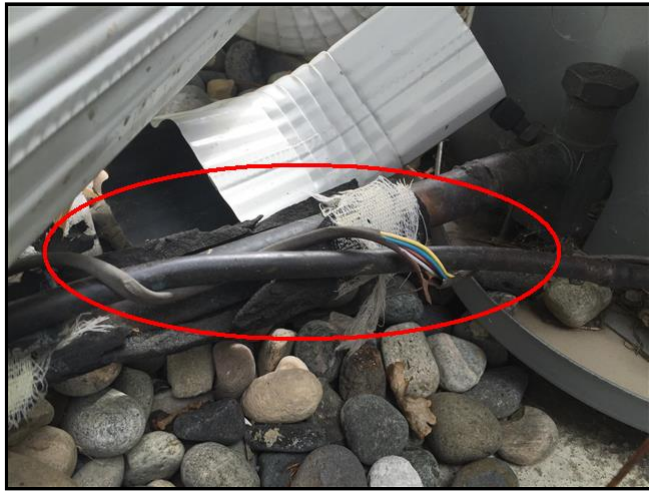
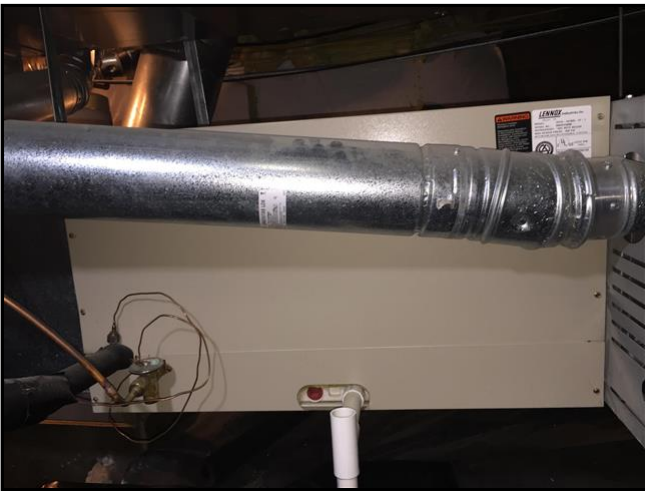
8.8 (1) Recommend the refrigerant line be fully insulated to improve efficiency. This is a maintenance item.

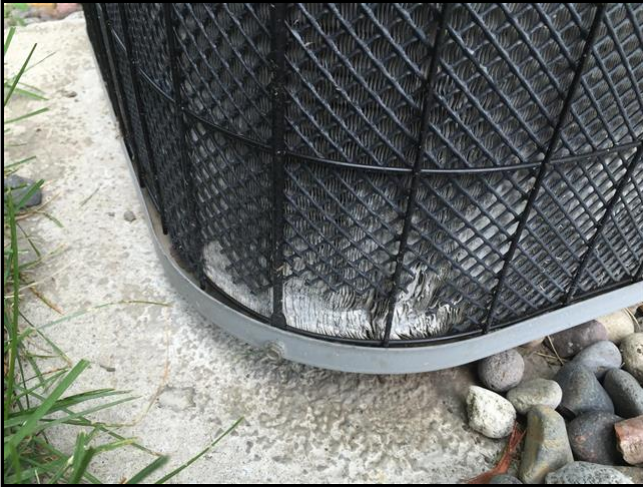
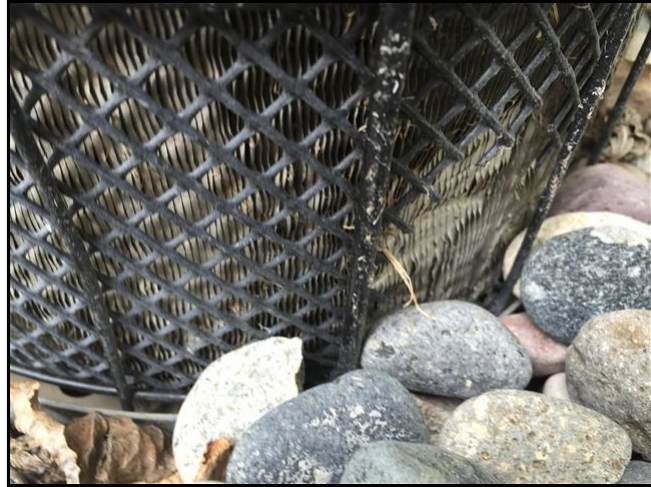
(2) General deterioration of the unit was observed on the heat dissipating fins on this unit. This can affect the efficiency of the unit and is consistent with its age. No repairs are necessary.

This system is 12 years old and the remaining useful life of the equipment is approximately 3-5 years. Recommend the unit be serviced and maintained by a qualified HVAC contractor.

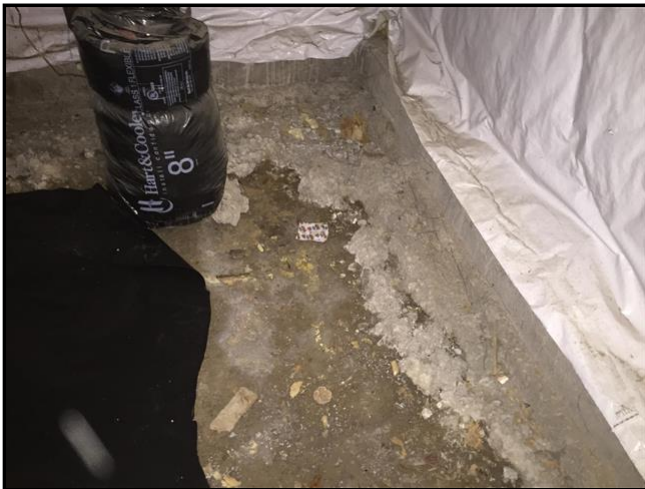
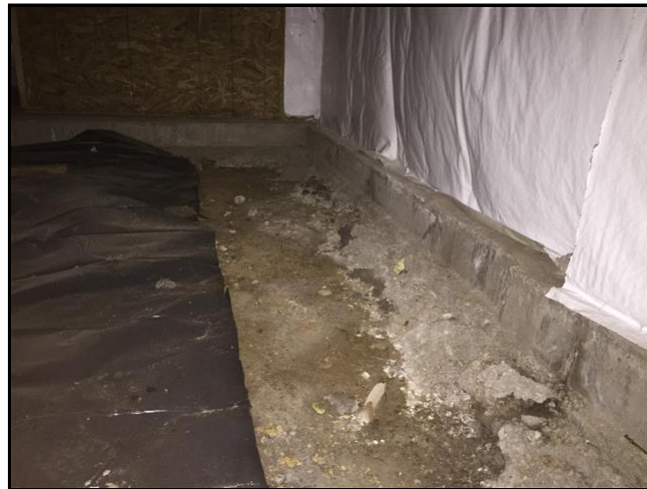
9.2 There are sections in the crawl space that are missing a vapor barrier. There is extra plastic material stored in the crawl space that can be used to cover these areas.
